1. OBJECT

Report on the behaviour of the surface treatment on Tabihaus® panels and in particular in the joint area.

It is made by the exposure to temperature of a coating with an acrylic mortar placed on two Tabihaus® panels connected by a joint and fixed on studs simulating the behaviour of a partition wall with its encounters, joints, floor, ceiling and corners.

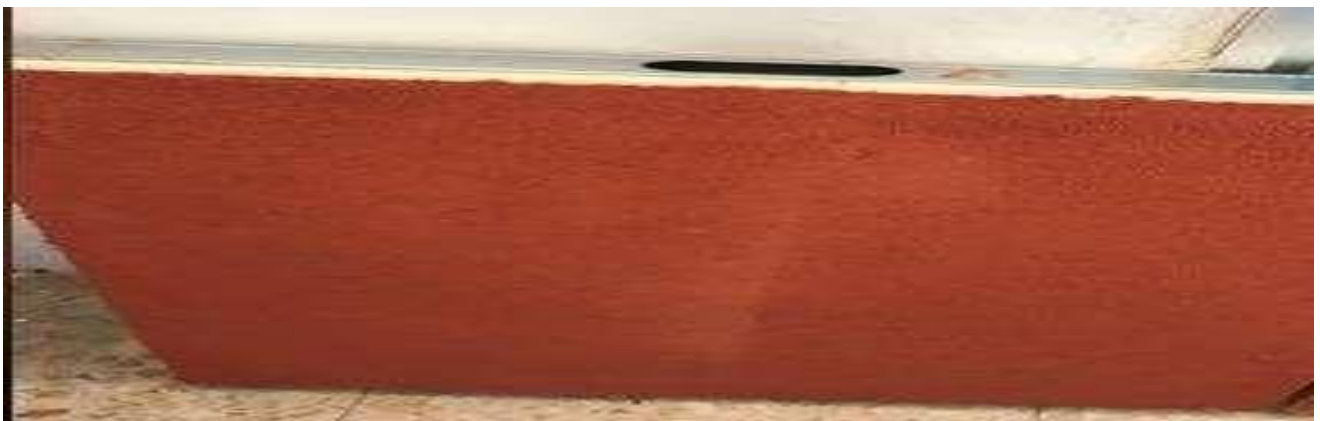
8+20 Tabihaus® panel. (1) -

- 1) 8 mm magnesium sulphate board
- 2) 20 mm thick high-density polystyrene

- 3) Fixing Polymer (Board joint)
- 4) Fixing Polymer (Board joint)
- 5) Fastening screws
- 6) Structural studs and channels
- 7) 2 mm thick acrylic coating

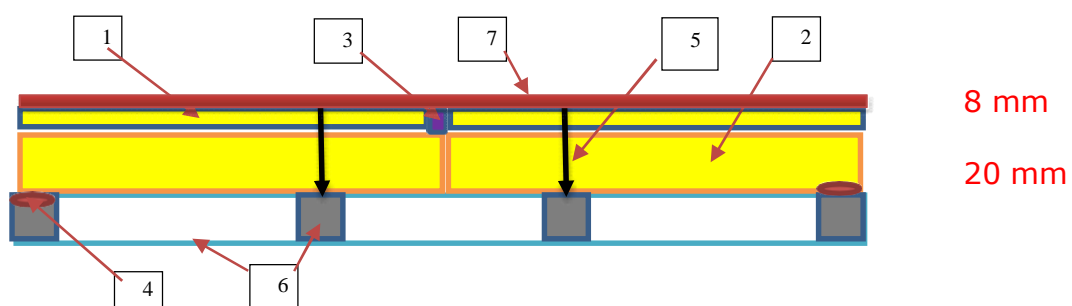
a) The joints between panels are in contact by the joint of both panels (no separation).

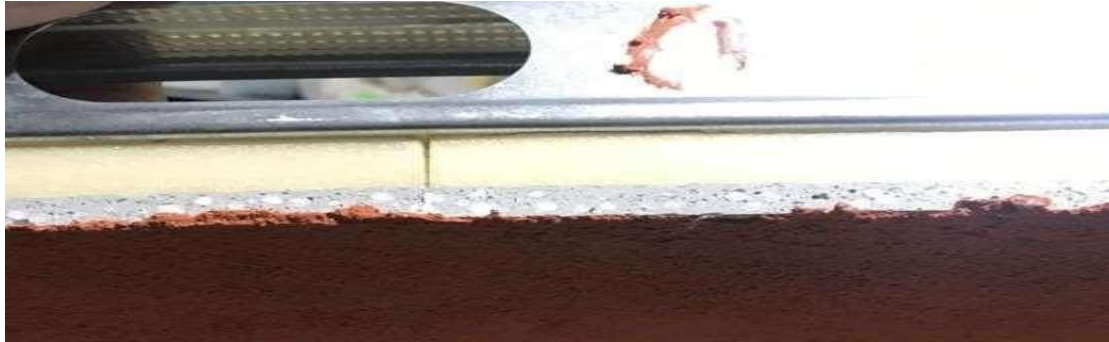
8+20 Tabihaus® panel. (2) –

- 1) 8 mm magnesium sulphate board
- 2) 20 mm thick high-density polystyrene

- 3) Fixing polymer (Board joint)
- 4) Fixing polymer (Board joint)
- 5) Fastening screws
- 6) Aluminium perimeter
- 7) Structural studs and channels
- 8) 2 mm thick acrylic coating

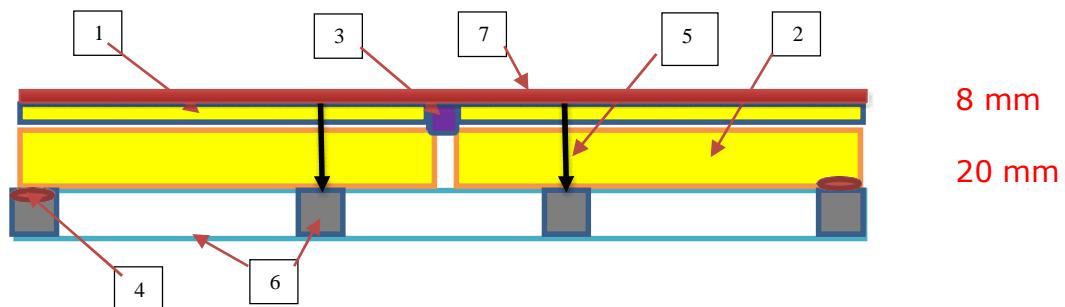
b) The joints between panels are 2 mm separated by the joint of both panels.

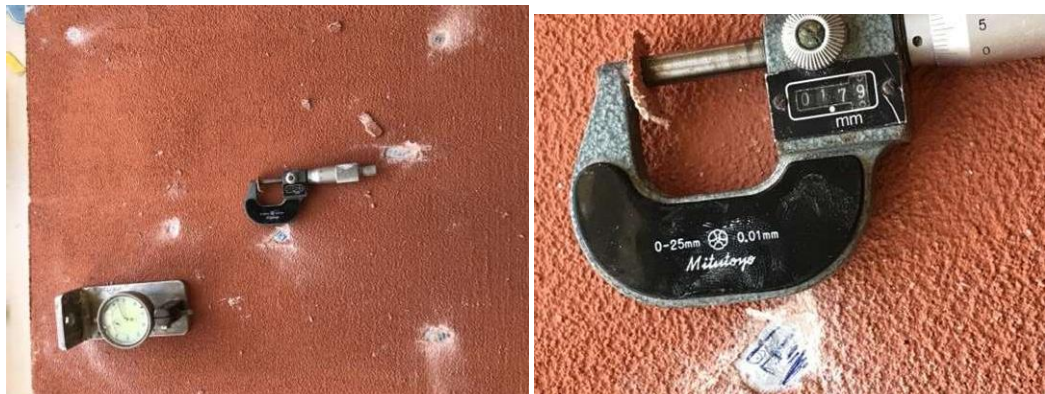
- **Thicknesses obtained in the application:**

Thickness values range from 1.2 to 2 millimetres thick

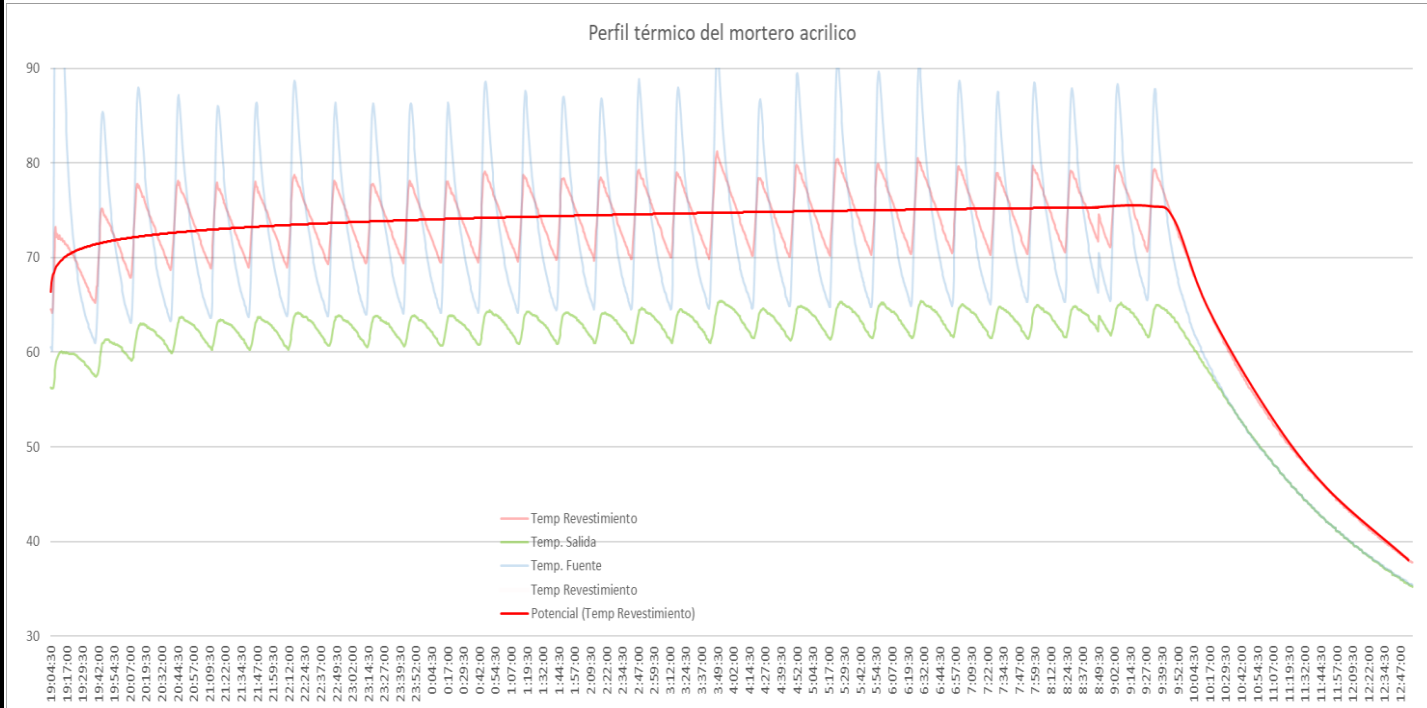
• **Thermal profile obtained:**

In the graph we consider the potential straight line (red line) to remove the sawtooth that gives us the start and stop of heat energy from the source. Until it joins with the drop produced by the stop of the heat source. This is a free fall.

As shown in the figure, the source of heat input is the blue line, and the green line is the ambient temperature in the chamber or outlet.

The test is subjected to heat conditions with gentle uphill ramps and a downhill ramp due to a power outage. This makes it steeper, but it is still approximately 10°C/hour. The uphill ramp is not reflected from the beginning, being approximately 15°C/hour. With these maximum values of 80°C of temperature, it is considered that the partition is taken to extreme conditions. Even so, with this thermal jump of 50°C no cracks are observed.
