1. OBJECT

Study of the behaviour of 2- and 6-mm expansion joints treated on Tabihaus® panels.

<p style="text-align: center;">GELSA</p>	<p>FAPYLSA R&D+I LABORATORY</p> <p><i>Behaviour of joint treatment in Tabihaus® sandwich panels</i></p>	  <p>Code: EN AND 0221 Page 4 of 6 DATE: November 2021</p>
---	--	---

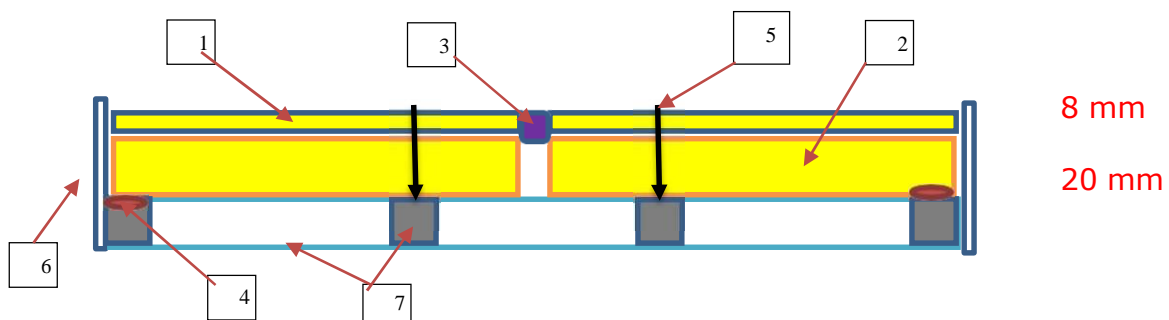
8+20 Tabihaus® panel. (2) –

- 1) 8 mm magnesium sulphate board
- 2) 20 mm thick high-density polystyrene

Accessories

- 3) Tabihaus® polymer
- 4) Tabihaus® polymer
- 5) Fastening screws
- 6) Aluminium perimeter
- 7) Structural studs and channels

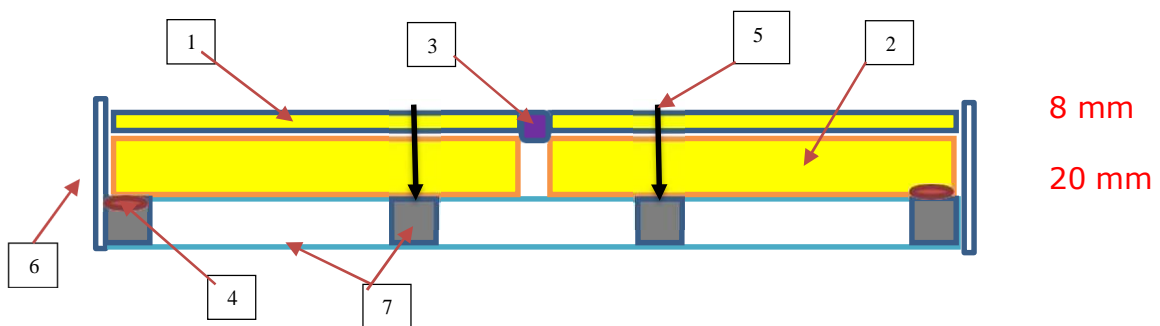
8+20 Tabihaus® panel. (3) –

- 1) 8 mm magnesium sulphate board
- 2) 20 mm thick high-density polystyrene

Accessories

- 3) Tabihaus® polymer
- 4) Tabihaus® polymer
- 5) Fastening screws
- 6) Aluminium perimeter
- 7) Structural studs and channels

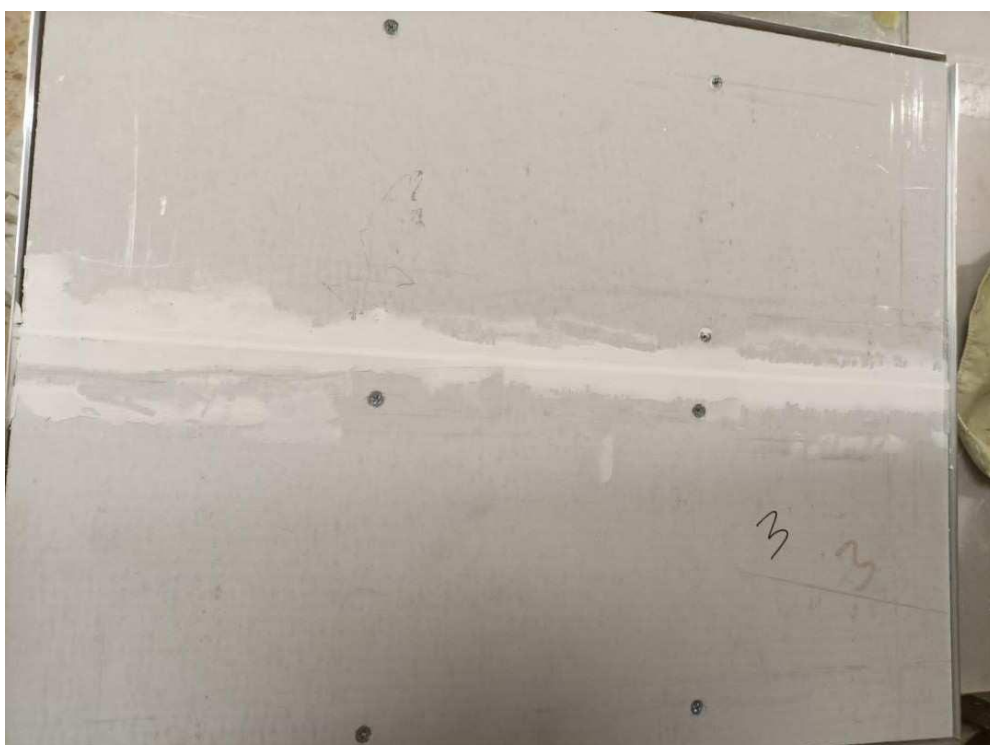
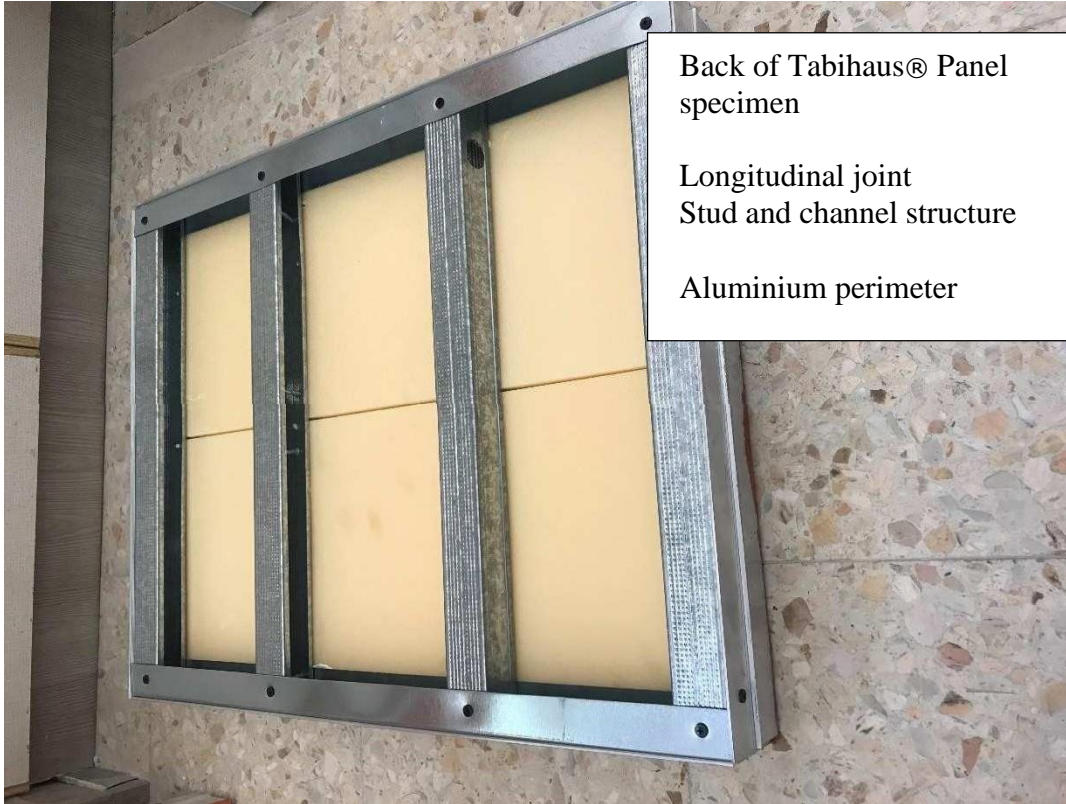
Back of Tabihaus® Panel specimen

Longitudinal joint
Stud and channel structure

Aluminium perimeter

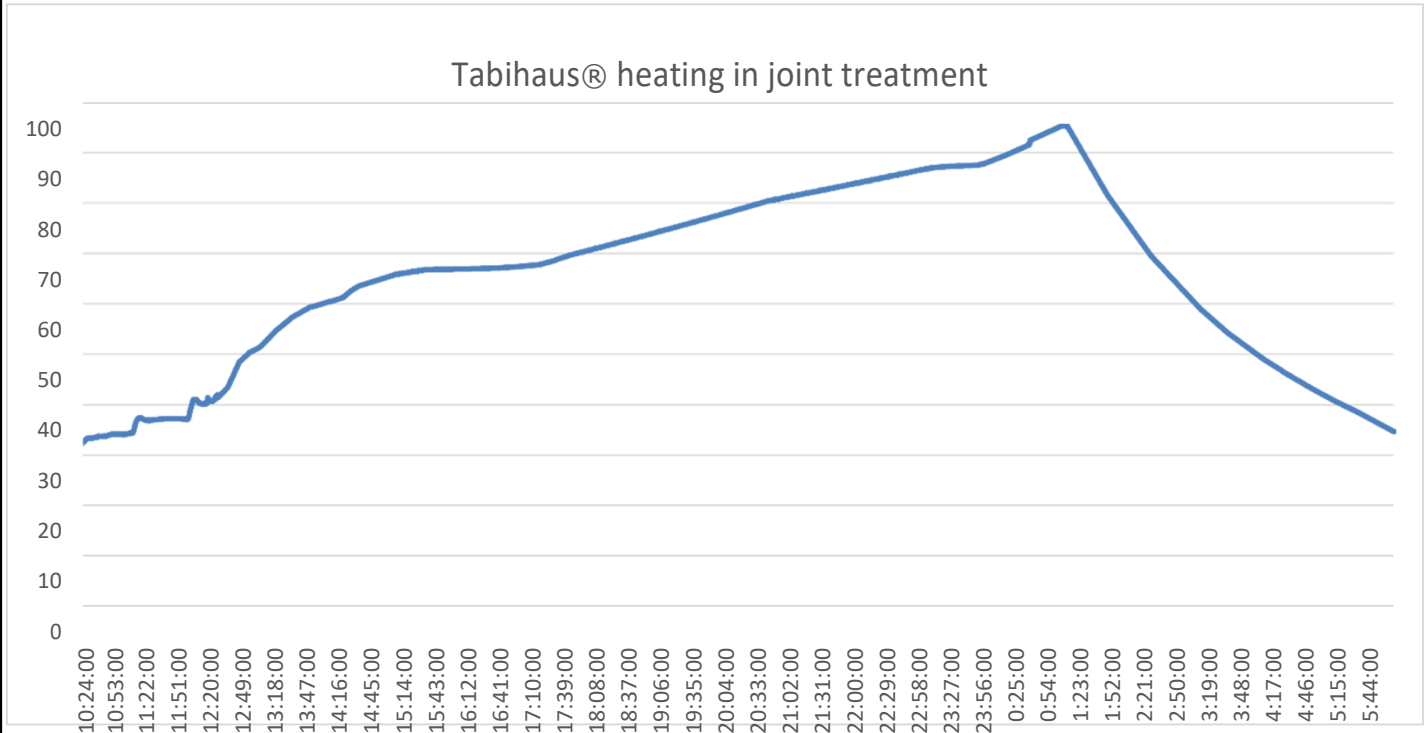
- **Thermal profile obtained:**

The test is subjected to heat conditions with gentle uphill ramps and a downhill ramp due to a power outage. This makes it steeper, but it is still approximately 12°C/hour. In other words, the very gentle ascent ramp is compensated by the descent ramp to allow for extreme situations such as the 65°C thermal jump without cracking.

- The method used is the exposure of the panels to temperatures from 30°C to 94°C.
- 1) 8+20 panel (1) and (2)
 - Panels (1) and (2) are placed with the furnace at 30°C.
 - The temperature is raised progressively until it reaches extreme temperatures such as in this case 94°C.
 - Once this temperature is reached, it is lowered for progressive cooling.
 - Subsequently, the existence or not of cracks in the joints is observed.
